# Three Decades after Chernobyl: Technical or Human Causes?

Nikolaus Muellner<sup>1</sup>

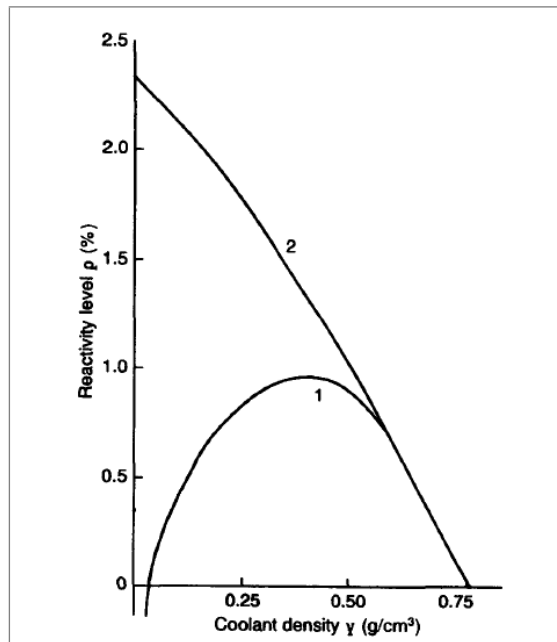
**Fig. 4**

Reactivity vs coolant density in a fuel channel. (1) Assumptions of the designers, reactivity negative for voided channel, (2) reality, reactivity strongly positive for voided channel (Abagyan et al. 1991)

Shteynberg (1991) points out that the impact of the steam fraction in the cooling channel on the reactivity was only evaluated for performance levels above 50% of the nominal reactor power (i.e. 1600 MWth and upwards). The accident happened at an operating power of about 200 MWth, a region which should prove to be

particularly unstable. However, as Shteynberg (1991) concludes, the designers did not expect any problems with this power range (which, according to him, is shown by the lack of supporting calculations for this range) and the operators were also unaware of the risks of operating the reactor in this dangerous power region.

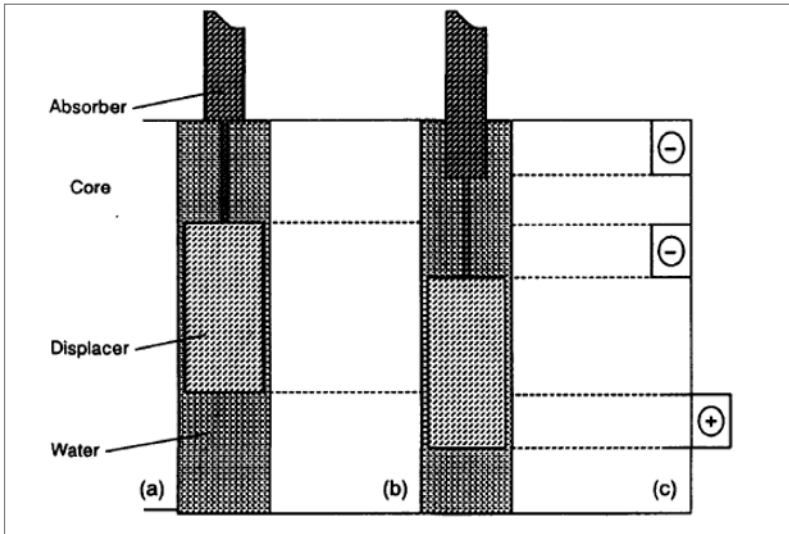
According to Shteynberg (1991), as well as by Abagyan et al. (1991), the design of the control rods triggered the accident. The RBMK reactor core is large compared to other cores, therefore a large number of control rods are necessary to ensure an even power distribution. The so called “operational reactivity margin” (ORM) is a very important operational parameter for RBMK reactors which played a key role in the accident. Roughly speaking it specifies for the RBMK reactor how many control rods are fully extracted at a certain point in time. More precisely, the ORM reports the “equivalent” withdrawn control rods, which means that two control rods withdrawn to 50% count as one. Furthermore not all control rods are equally effective, and furthermore effectiveness of a rod is not equal over the whole size. The algorithm for calculating the ORM takes those effects into account. According to the operating instructions, there is a minimum value for the ORM value, which must not be exceeded. There must always be 26–30 equivalent control rods withdrawn. The main engineer may permit operation also down to an ORM value of 15 equivalent control rods. Operation below this value is not permitted.

But the ORM value has a critical influence on the safe shutdown of the reactor. Due to the design of the control rods, the efficiency of the reactor SCRAM (the emergency shutdown) system was linked to the ORM value. When the reactor emergency shutdown was triggered at an ORM value of 30 and more, negative reactivity could very quickly be introduced to reduce the power; at an ORM value of 15 it took six seconds to introduce the relatively small value of 1\$ of negative reactivity; and at an ORM value of 7 the introduced reactivity was positive over 8 seconds (which means the reactor power increases further for eight seconds when the operator hits the emergency shutdown button). Only after that the power would decrease (Shteynberg 1991). The design of the control rod is the reason for this effect: to ensure better performance during normal operation when the control rods are fully withdrawn, displacement bodies made of graphite were fitted with telescope rods at the lower end of the control rods. This means that during normal operation the middle of the core region (approximately 7m) was filled with a graphite displacer of 5m (see Figure 5). Above and below the displacer in the reactor core was a 1 m water column. When a fully withdrawn control rod was inserted, the graphite displacer had to pass through 1m of water in the lower core region. However at this position the water acts as a neutron absorber, the graphite body acts as a moderator, which means that positive reactivity is introduced into the lower region of the reactor (power is increased). In the upper part of the reactor core, negative reactivity is inserted because the absorber material is introduced into the core (see Figure 5). If the rods are already one meter inserted, the graphite displacer will be at the bottom of the core, and no positive reactivity will be introduced. This is the reason why a minimum ORM value is enhancing safety – it means, that a certain number of rods are already inserted into the core.

**Fig. 5** Design of the control rods of the reactor protection system (Abagyan et al. 1991) (a) rod completely withdrawn with graphite displacer (b) situation while inserting the rod introducing positive reactivity over several seconds in the lower part of the core.

In fact it was just the actuation of the emergency shutdown system (its particular design with graphite displacers at the bottom) that destroyed the reactor, and, contrary to the statement in INSAG (1986), would the system have been actuated automatically, it would have destroyed the reactor as well. The accident occurred at 1:24 and according to Shteynberg (1991) already at 0:30 the conditions in the reactor were such that a shutdown with the shutdown system was not possible anymore. As was said earlier, due to the particular design and low value of ORM, the shutdown system increased the reactor power for eight seconds, before causing a reduction. And at 200 MWth, the reactor power coefficient was strongly positive, which means that an increase in power would lead to a further increase. Those two circumstances together led to the power surge that destroyed the reactor.
