## **INSAG-7 The Chernobyl Accident: Updating of INSAG-1**

A REPORT BY THE  
INTERNATIONAL NUCLEAR SAFETY ADVISORY GROUP

**THE CHERNOBYL ACCIDENT: UPDATING OF INSAG-1  
INSAG-7**

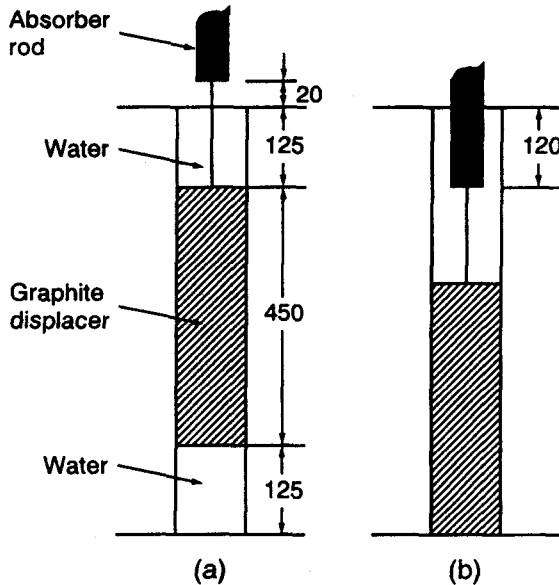
*FIG. 1. Uppermost position of a control rod of the RBMK emergency protection system relative to the reactor core (a) before and (b) after the improvements made in response to the Chernobyl accident. Dimensions are given in centimetres.*

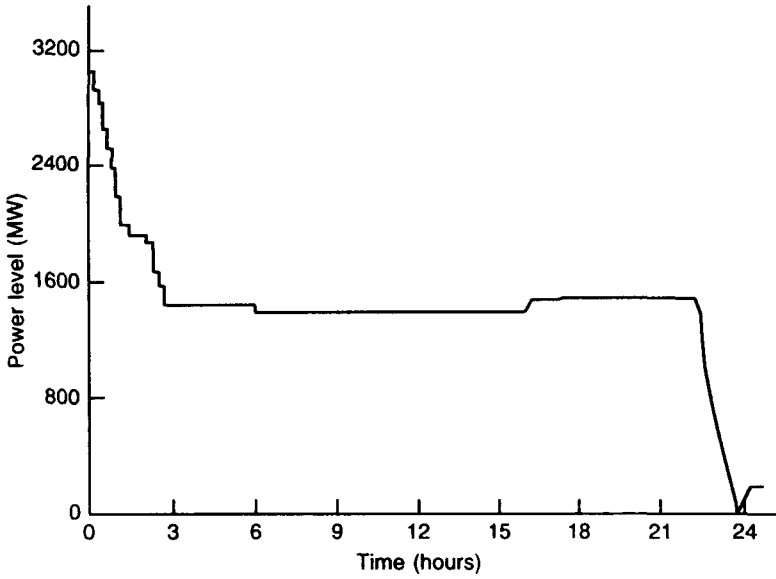
FIG. II-3. The Chernobyl accident: change in power level with time (from initiation of the power reduction).

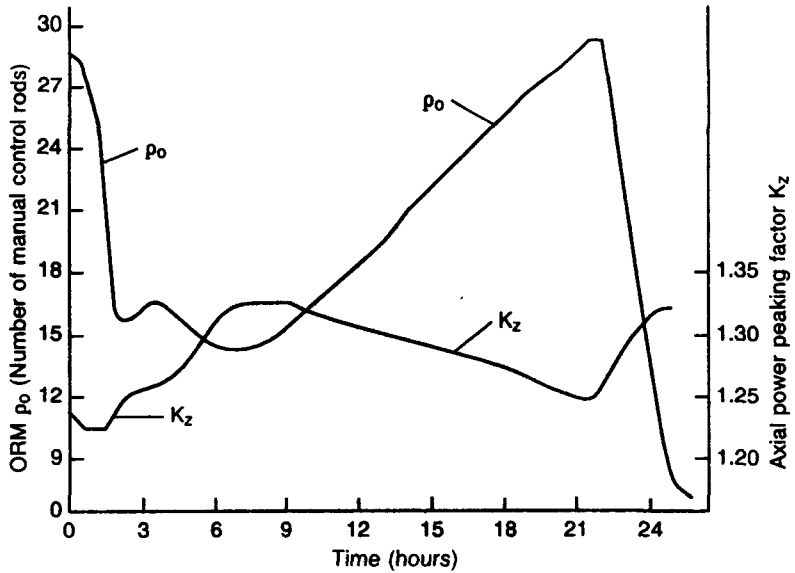
FIG. II-4. The Chernobyl accident: change in the operating reactivity margin  $\rho_0$  and the power peaking factor (non-uniformity factor of the axial field)  $K_z$  during the transient.

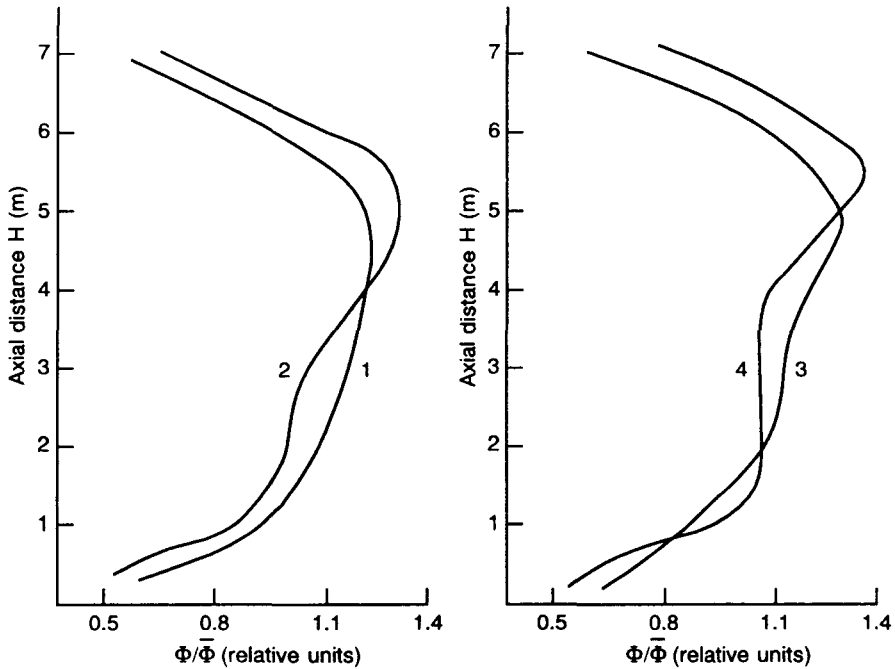
FIG. II-5. The Chernobyl accident: axial distribution of the thermal neutron flux density in the core at various times during the xenon transient preceding the accident: 1: 00:00; 2: 07:00; 3: 22:00; 4: 24:30 (before the accident).

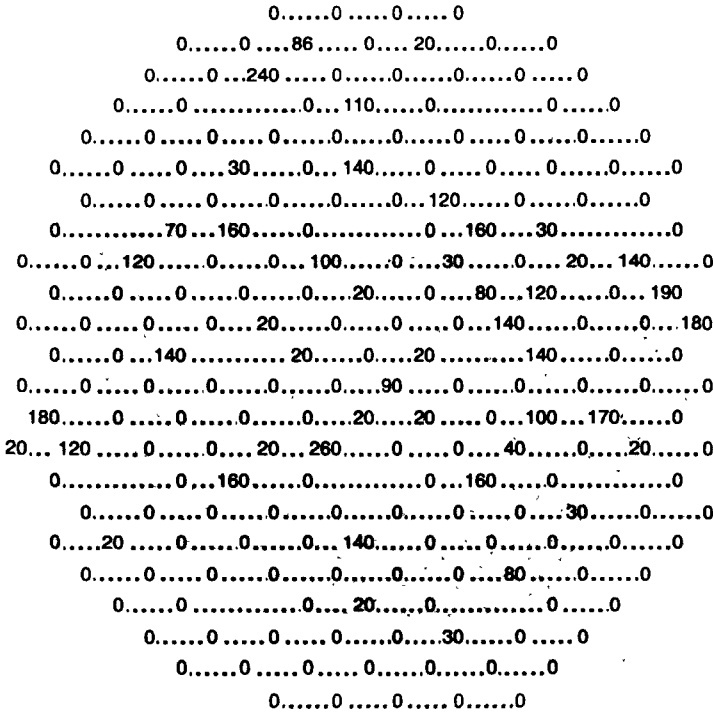
First of all, the positions of all the controllers (Fig. II-6) and the power density field for 01:22:30 on 26 April 1986 were reconstructed. The radial-azimuthal distribution is shown in Fig. II-7, and the readings from the axial distribution sensors in Fig. II-8. At the point in time corresponding to 01:23:40 on 26 April 1986, the insertion of all the RCPS rods into the core pursuant to the EPS-5 signal was simulated.

FIG. II-6. The Chernobyl accident: plan of the core showing the insertion depths of the RCPS rods in centimetres.

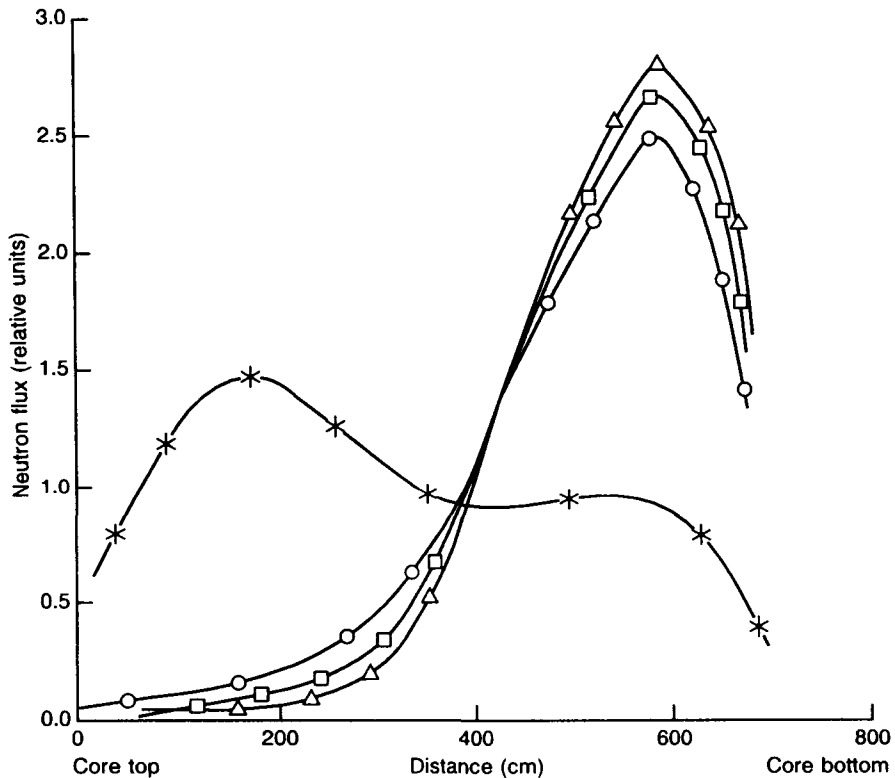
(Fig. II-9), and the reactivity and the integrated power level start to increase. Under abnormal conditions, this effect is caused by control rod design features: when the rod is inserted into the core from the top position (Fig. II-10), the multiplication factor in the bottom of the core increases owing to replacement of the neutron absorbing water column by the graphite displacer. The changes in the reactivity and the integrated power level which were generated by Model 1 are shown in Fig. II-11.

FIG. II-9. *The Chernobyl accident: distortion of the axial neutron fields during rod insertion at the time when the accident occurred. The displacement of the neutron flux maximum to the lower part of the core is clearly shown. Key: time after EPS-5 button was pressed: \*: 0 s; o: 4 s; □: 6 s; Δ: 7 s.*

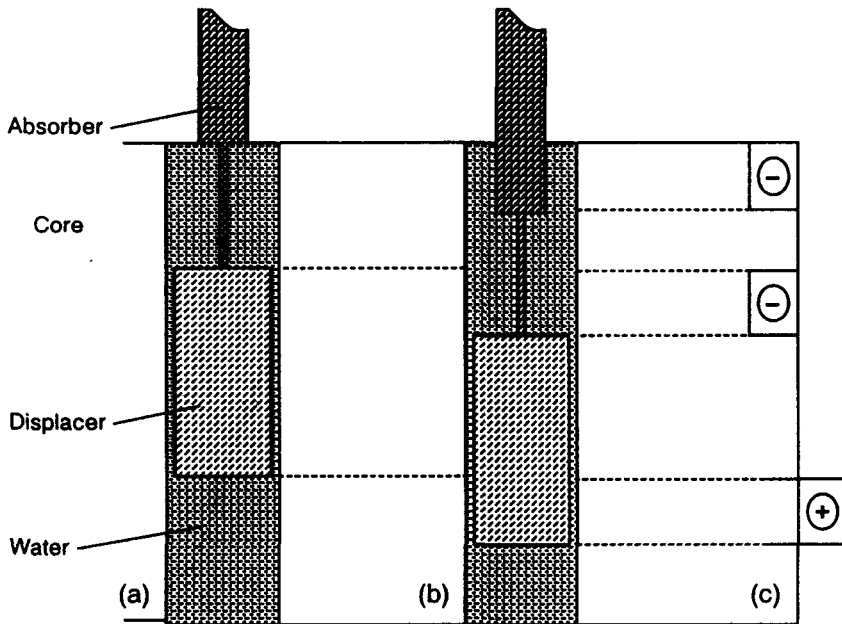
FIG. II-10. The RBMK reactor: schematic representation of the reactivity insertion caused by inserting the RCPS rods from the top position. (a) Manual control rod withdrawn; (b) manual control rod partially inserted; (c) the change in the theoretical reactivity insertion  $\delta k_{\infty}$  as the rod is inserted.

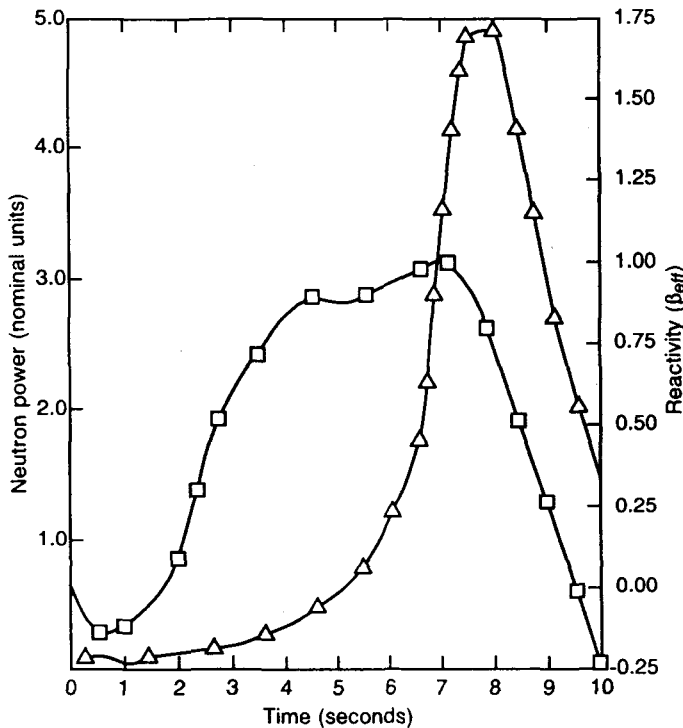
FIG. II-11. The Chernobyl accident: time dependence of the reactivity level and the neutron power during the initial phase of the accident.  $\square$ : reactivity;  $\Delta$ : neutron power. [Reactivity is expressed in units of effective delayed neutron fraction  $\beta_{eff}$ .]

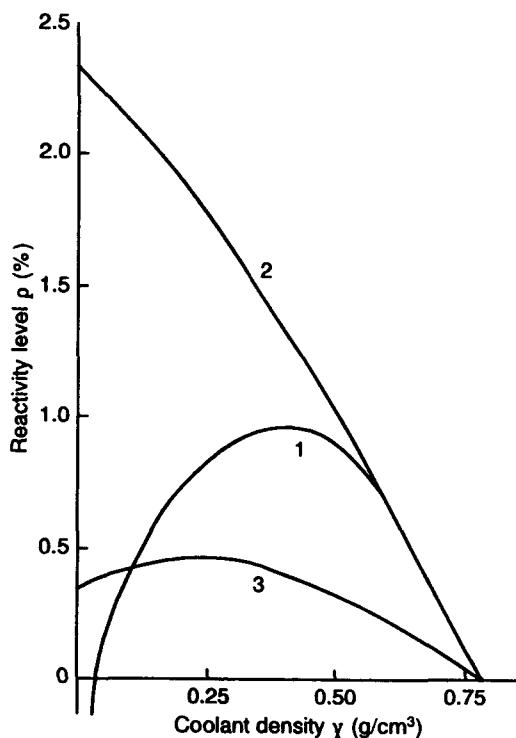
FIG. II-12. The RBMK reactor: dependence of the reactivity level  $\rho$  on the coolant density  $\gamma$ . 1: design calculations; 2: actual dependence at the time when the accident occurred on 26 April 1986; 3: current status after improvements.

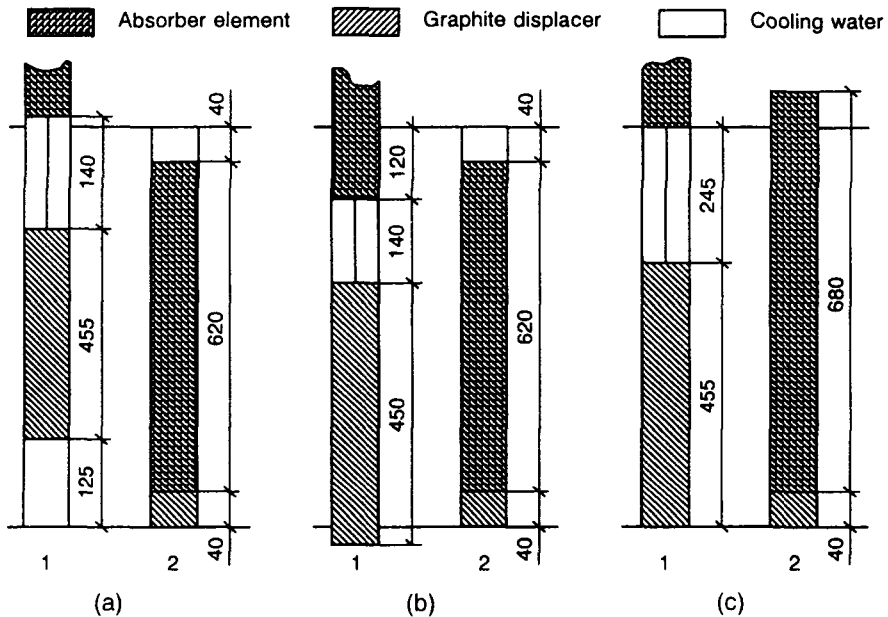
FIG. II-13. Manual control rods in the RBMK reactor. (a) old design rod; (b) old design rod inserted into the core to avoid the insertion of positive reactivity; (c) retrofitted rod. 1: rod withdrawn; 2: rod inserted. [Dimensions are given in centimetres.]

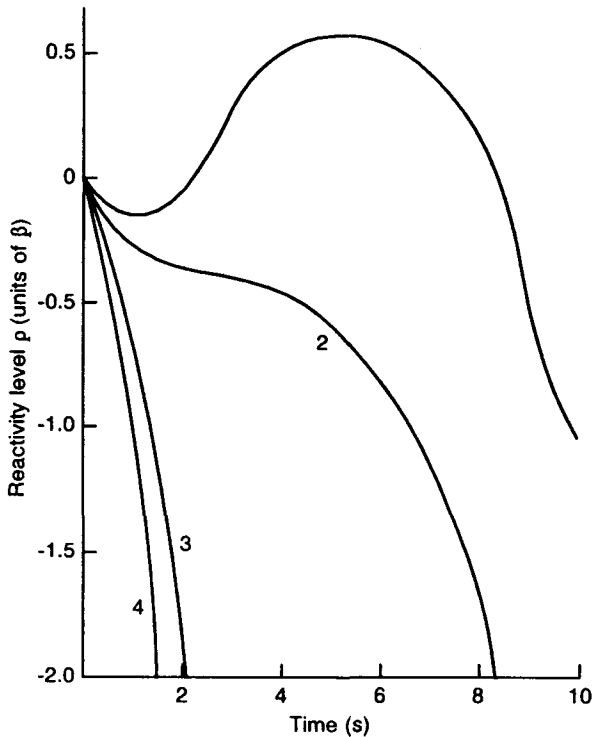
FIG. II-15. The RBMK reactor: efficiency of the emergency protection system. 1: the Chernobyl plant on 26 April 1986, ORM = 7 manual control rods (DBA conditions); 2: ORM as specified in the Operating Procedures (15 manual control rods); 3: retrofitted RCPS, ORM = 30 manual control rods; 4: retrofitted RCPS, fast acting emergency protection system in operation.
