Report on the accident at Windscale No. 1 Pile on 10 October 1957^{*}

Report on the accident at Windscale No. 1 Pile on 10 October 1957*

William Penney^{1,6}, Basil F J Schonland^{2,6}, J M Kay^{3,6},
Jack Diamond^{4,6} and David E H Peirson^{5,7}

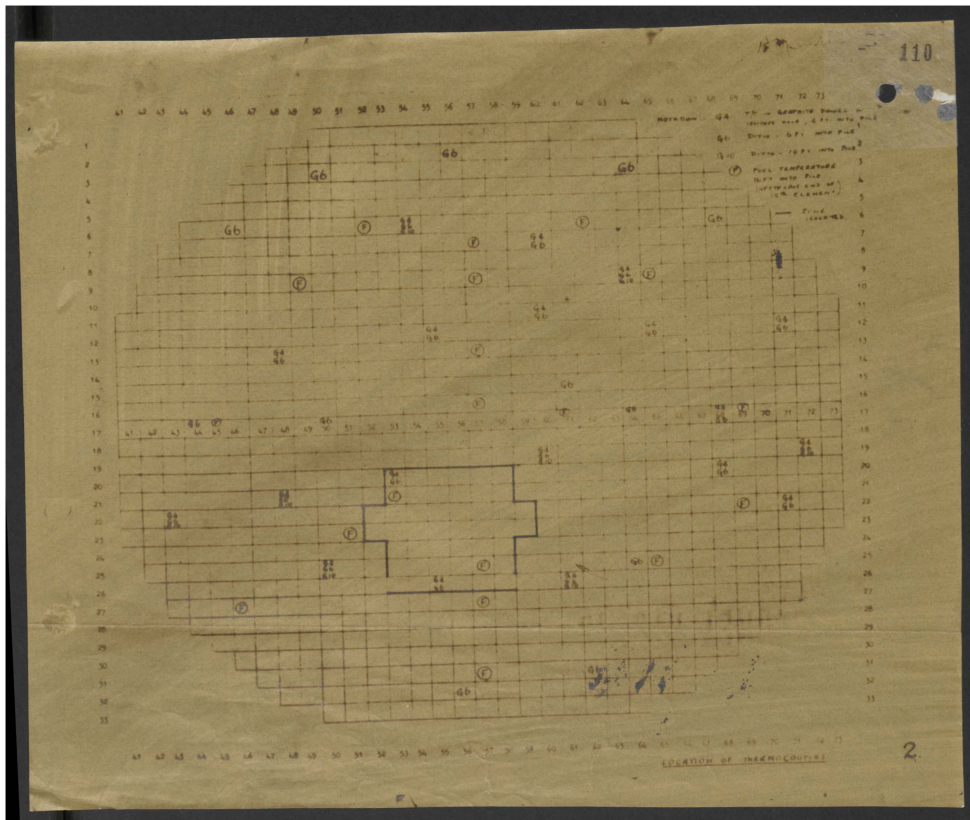
Appendix B. Location of thermocouples

* The location of the uranium and graphite thermocouples is shown at appendix B.

101. A major technical defect contributing to the accident was the inadequacy of instrumentation for the safe and proper operation of a Wigner release. The uranium thermocouples were correctly positioned for normal operations, but not for Wigner releases; moreover, in the condition of stagnant air which had necessarily been created within the pile, there was no means of detecting the smouldering uranium cartridges, which we believe to have been a key event in the development of the accident.
