## **INSAG-7 The Chernobyl Accident: Updating of INSAG-1**

A REPORT BY THE  
INTERNATIONAL NUCLEAR SAFETY ADVISORY GROUP

**THE CHERNOBYL ACCIDENT: UPDATING OF INSAG-1  
INSAG-7**

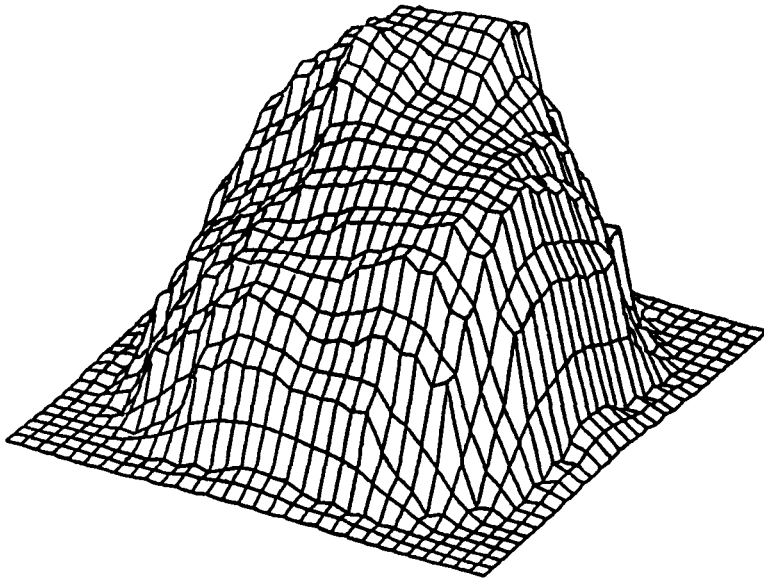
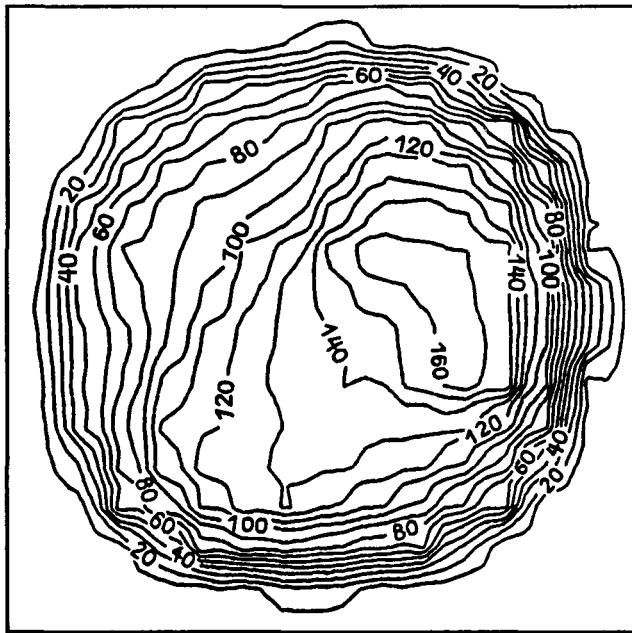
FIG. II-7. The Chernobyl accident: radial distribution of the initial neutron field in the core.

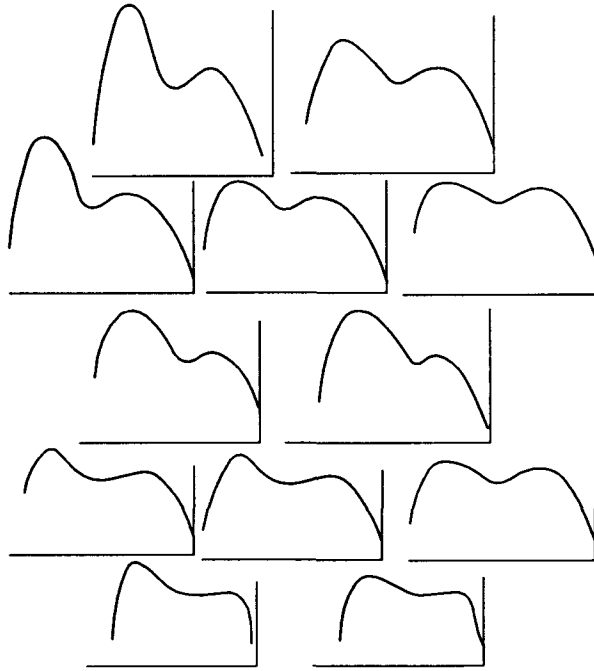
*FIG. II-8. The Chernobyl accident: distribution of the power density profile over the core volume as recorded by the axial detectors.*

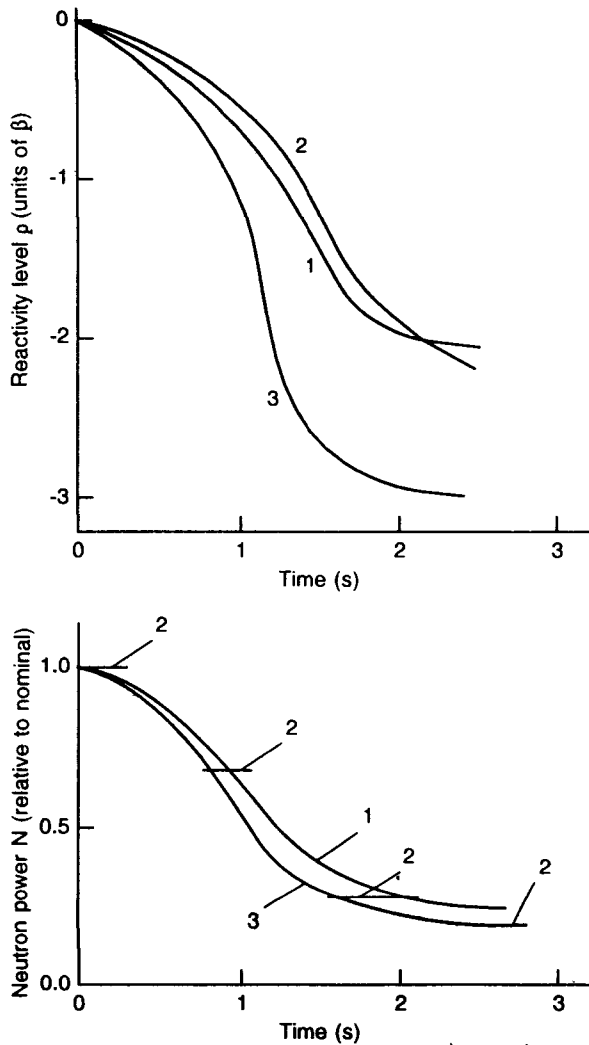
FIG. II-14. The RBMK reactor: reactivity level  $\rho$  and neutron power  $N$ : testing of the fast acting emergency protection system at the Leningrad and Ignalina nuclear power plants.  $N_p = 0.4 N_{nom}$ . 1: theoretical calculations; 2: experiment at the Leningrad plant; 3: experiment at the Ignalina plant.
